Investigation of rapid remote sensing techniques for forensic wind analyses

1.1. Hurricane Harvey

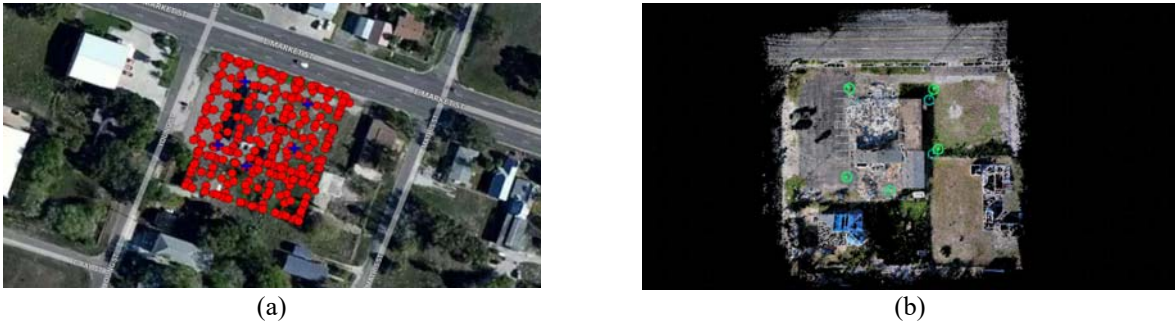
Figure 1. VFW flight details: (a) image locations in red and (b) GCPs shown in green

The available equipment for the aerial surveys was a DJI Inspire 2 UAS with an onboard Zenmuse X5 camera and mounted 15 mm lens. Flight paths were autonomously controlled with the Pix4dcapture application on a handheld android-based tablet, using perpendicular “lawn-mower” like passes due to the various changes in height in the scenes (Figure 1). At Rockport VFW, three flights were performed with an 85% overlap at an above-ground-level (AGL) altitude of 25 meters. Similarly, two flights were conducted at the Aransas Pass Storage Center with 85% overlap and an AGL altitude of 28 meters. This produced a total of 302 and 639 images, for the VFW and storage center locations. The resultant ground sampling distance was between 0.55 – 0.61 cm. Ground control points (GCP) were well distributed to scale the SfM resultant point cloud.

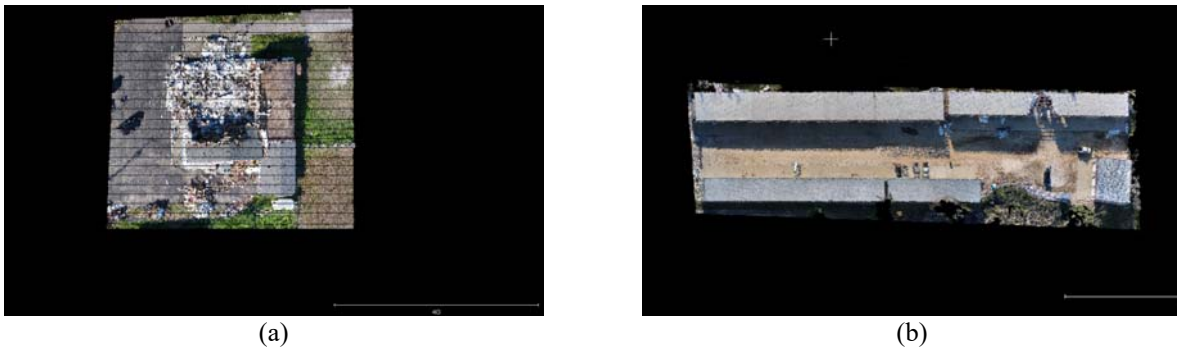
Pix4d is a commercial software commonly utilized for UAS processing, which utilizes high resolution images and form them to produce accurate deliverables, including digital models, point clouds, etc. The processing template for data processing is selected as 3D maps, image scale at one-half, point density of optimal, and the minimum number of matches of 3. The SfM point clouds of Rockport VFW and Aransas Pass storage are displayed in Figure 2. The total number of points in each cloud are 143 and 460 million, respectively.

Figure 2. SfM derived point clouds: (a) VFW and (b) Aransas Pass storage facility
